Flood Control Project Maintenance**2012 Structure Summary Report****Overall Unit and Item Ratings****Lower San Joaquin Levee District****Ash Slough Drop Structure No. 1**

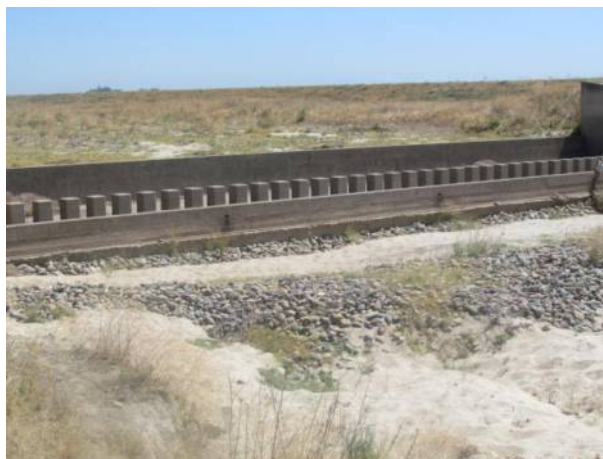
richard_t_20120731_136.JPG

Looking northeast at downstream side of structure riprap displacement.

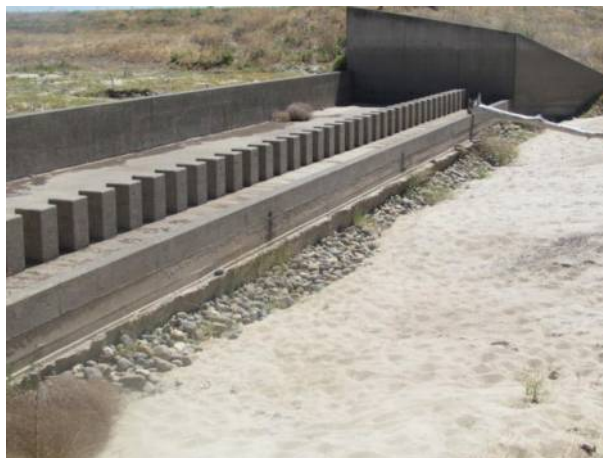
richard_t_20120731_137.JPG

Looking east at riprap displacement on downstream side of structure.

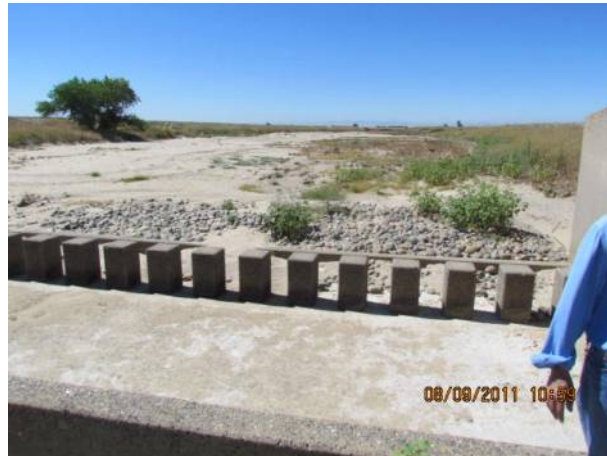
richard_t_20120627_007.jpg

Looking west at revetment on downstream side of structure.

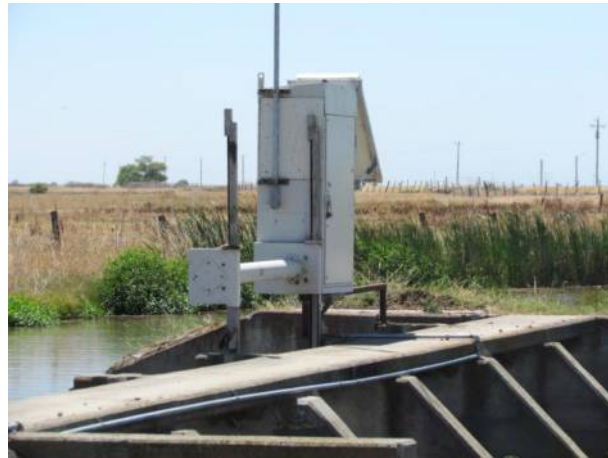
Levee Mile Report Line	6
Start Levee Mile	0.00
End Levee Mile	0.00
Location	
Category	Structures
Item	Encroachments
Looking north at electric control gate on east side of structure.	
richard_t_20120730_086.JPG

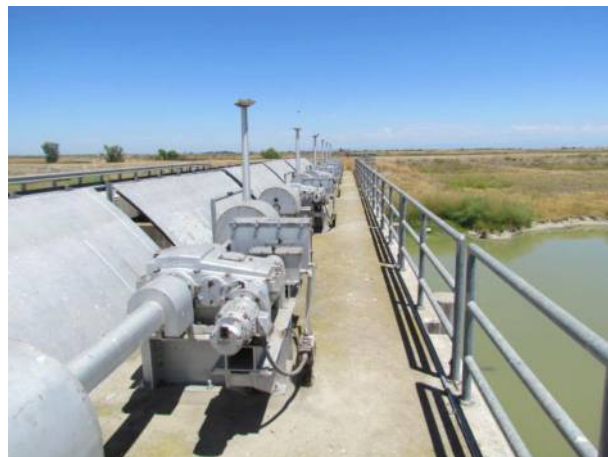
Levee Mile Report Line	13
Start Levee Mile	0.00
End Levee Mile	0.00
Location	
Category	Structures
Item	Electric Gate Operators
Looking north at several electric motors on upstream side of structure	
richard_t_20120730_113.JPG

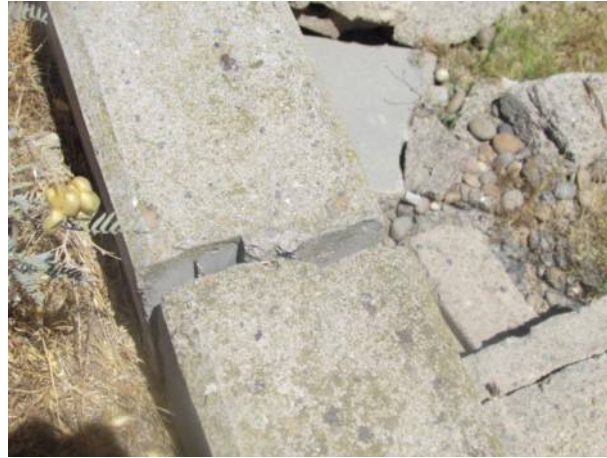
richard_t_20120731_155.JPG

Looking at joint separation on left side of structure.

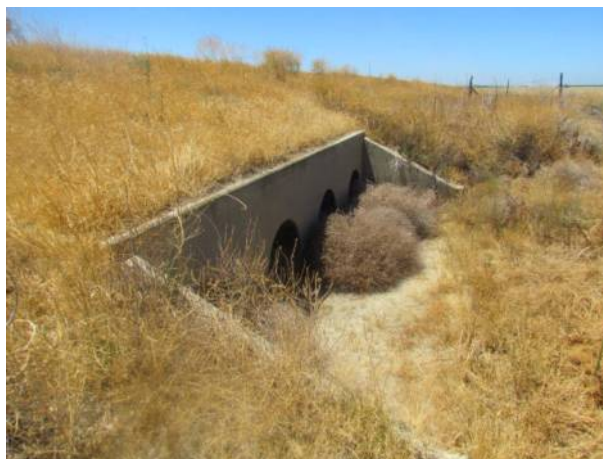
Levee Mile Report Line	7
Start Levee Mile	0.00
End Levee Mile	0.00
Location	
Category	Structures
Item	Culverts: Inlets / Outlets
Looking west at overview of inlet.	
richard_t_20120731_157.JPG

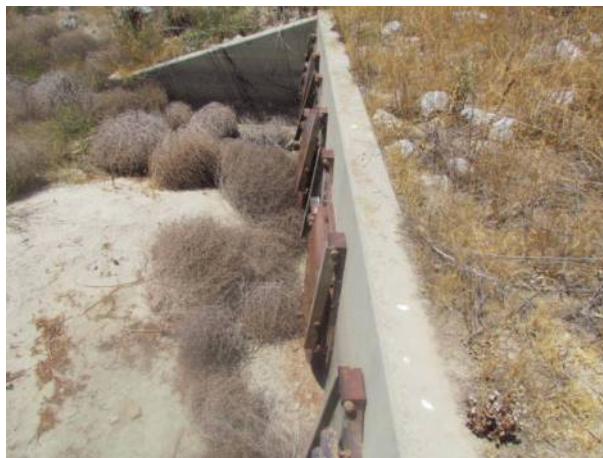
Levee Mile Report Line	11
Start Levee Mile	0.00
End Levee Mile	0.00
Location	
Category	Structures
Item	Flap Gates
Looking west at flap gates.	
richard_t_20120731_159.JPG

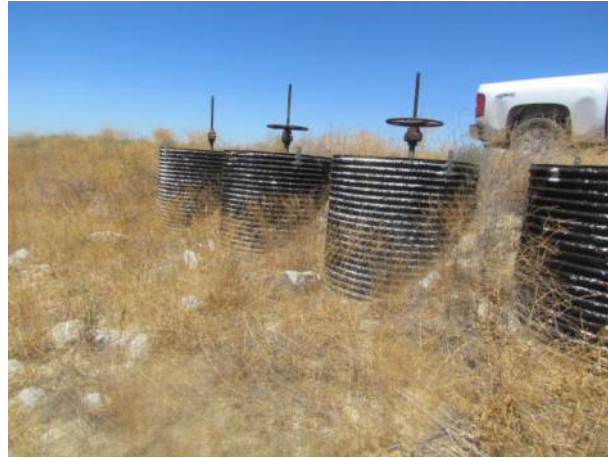
Levee Mile Report Line	14
Start Levee Mile	0.00
End Levee Mile	0.00
Location	
Category	Structures
Item	Manual Gate Operators
Looking south at screw gates	
richard_t_20120731_158.JPG

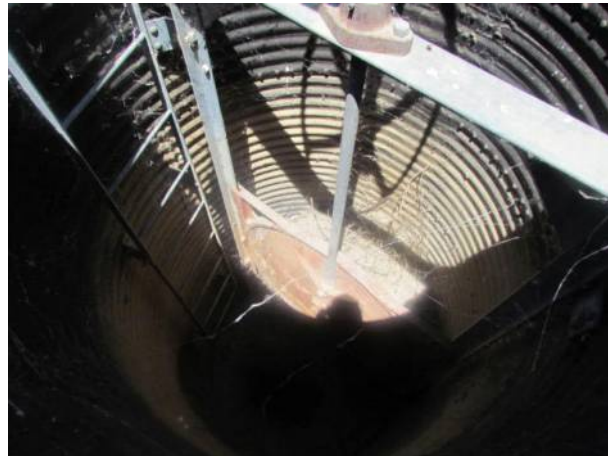
Levee Mile Report Line	14
Start Levee Mile	0.00
End Levee Mile	0.00
Location	
Category	Structures
Item	Manual Gate Operators
Looking at screw gate inside can.	
richard_t_20120731_160.JPG

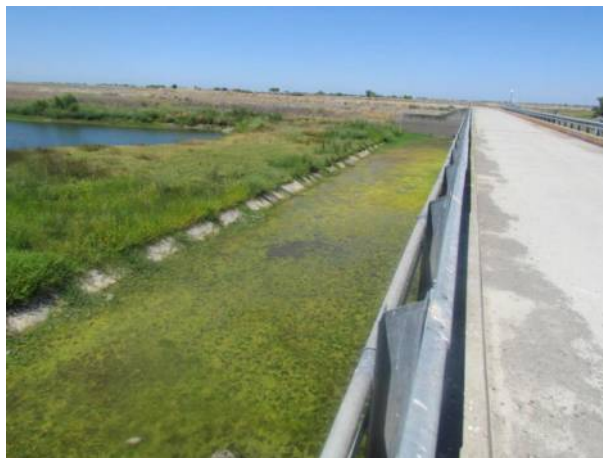
richard_t_20120730_123.JPG

Looking northwest at downstream side of structure.

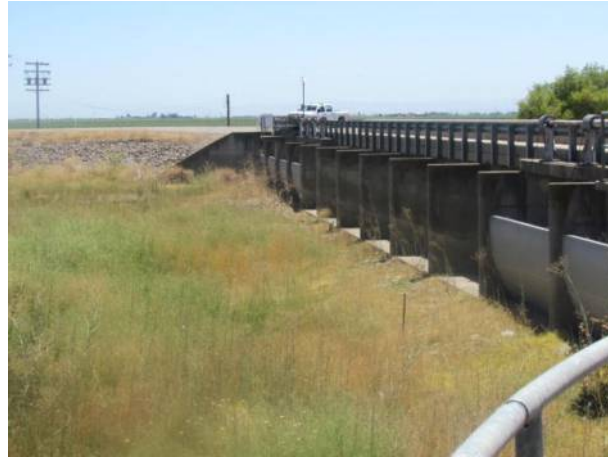
Levee Mile Report Line	1
Start Levee Mile	
End Levee Mile	
Location	
Category	Structures
Item	Photo Documentation
Looking south at overview of upstream side of structure.	
richard_t_20120730_124.JPG

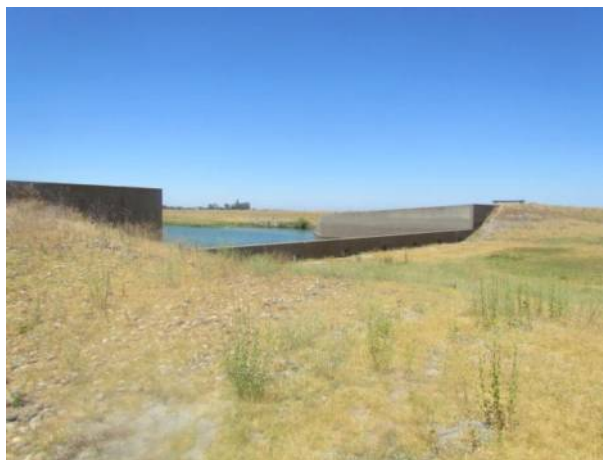
Levee Mile Report Line	1
Start Levee Mile	
End Levee Mile	
Location	
Category	Structures
Item	Photo Documentation
Looking west at upstream side of structure.	
richard_t_20120730_115.JPG

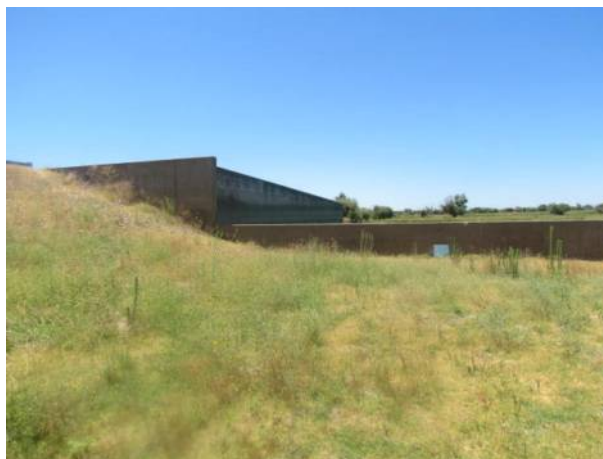
Levee Mile Report Line	1
Start Levee Mile	
End Levee Mile	
Location	
Category	Structures
Item	Photo Documentation
Looking west at left wing wall on downstream side of structure.	
richard_t_20120730_116.JPG

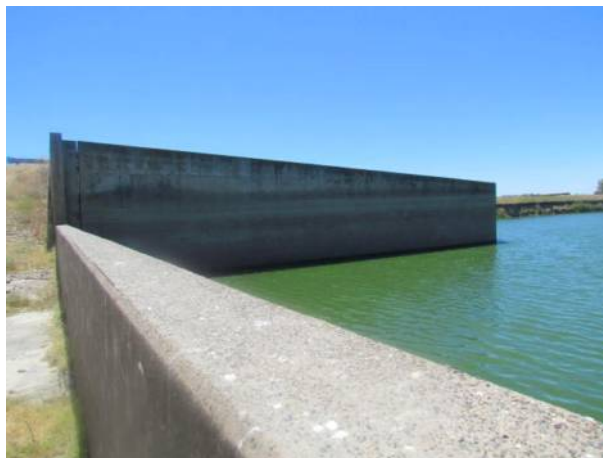
Levee Mile Report Line	1
Start Levee Mile	
End Levee Mile	
Location	
Category	Structures
Item	Photo Documentation
Looking south at left wing wall on downstream side of structure.	
richard_t_20120730_117.JPG

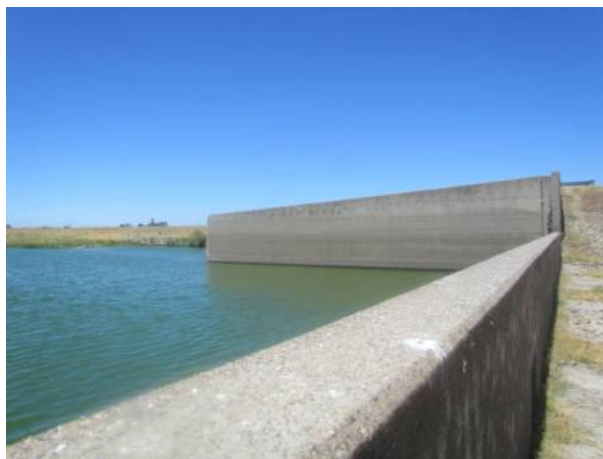
Levee Mile Report Line	1
Start Levee Mile	
End Levee Mile	
Location	
Category	Structures
Item	Photo Documentation
Looking north at right wing wall on downstream side of structure.	
richard_t_20120730_118.JPG

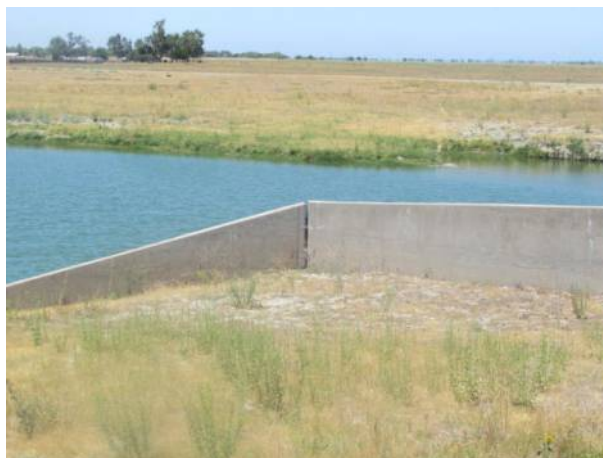
22	0.00	0.00	Structures	Monolith Joints		A	Inspector Comments: Some movement at left wing wall joints.	37.201227 ° -120.755223 °	37.201227 ° -120.755223 °	22 Y
23	0.00	0.00	Structures	Safety		A	Inspector Comments: No visible safety hazards.	37.201227 ° -120.755223 °	37.201227 ° -120.755223 °	23

Levee Mile Report Line	22
Start Levee Mile	0.00
End Levee Mile	0.00
Location	
Category	Structures
Item	Monolith Joints
Looking north at joint on left wing wall on downstream of structure.	
richard_t_20120730_119.JPG

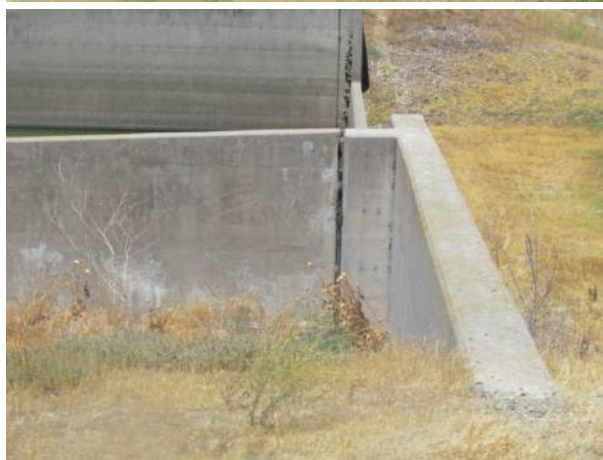
Levee Mile Report Line	22
Start Levee Mile	0.00
End Levee Mile	0.00
Location	
Category	Structures
Item	Monolith Joints
Looking at joint on left wing wall.	
richard_t_20120730_120.JPG

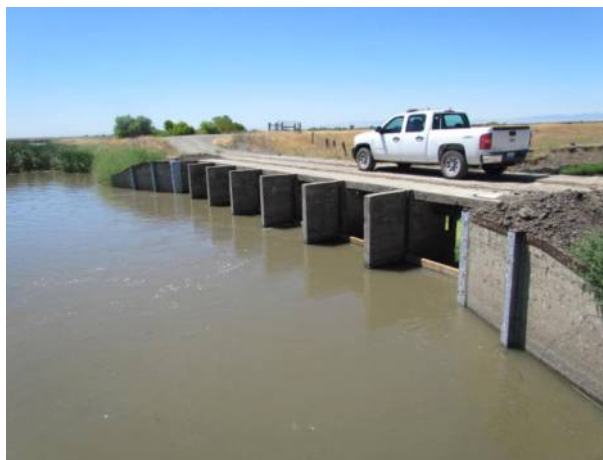
richard_t_20120730_094.JPG

Looking at upstream side of structure.

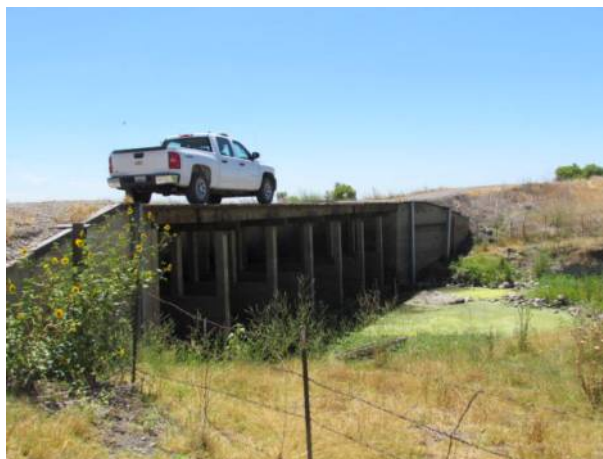
richard_t_20120730_095.JPG

Looking at downstream side of structure

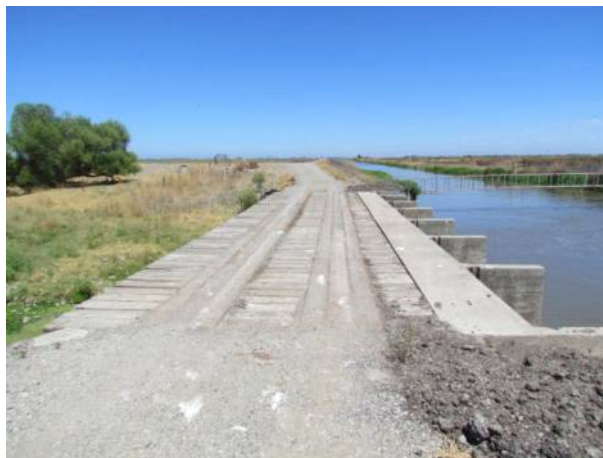
richard_t_20120730_096.JPG

Looking east at overview of structure.

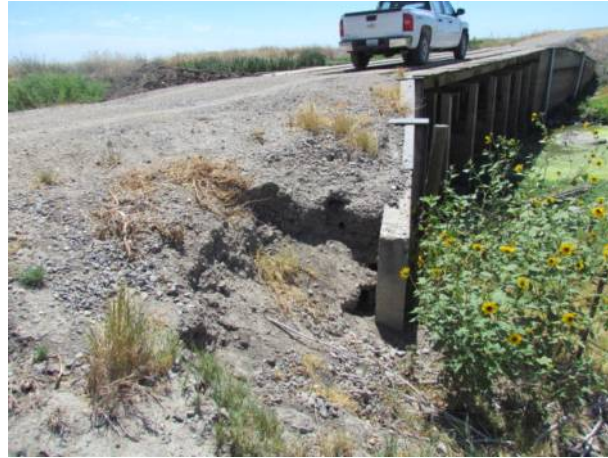
Levee Mile Report Line	4
Start Levee Mile	0.00
End Levee Mile	0.00
Location	
Category	Structures
Item	Erosion / Bank Caving
Looking at bank caving near right wing wall on downstream side of structure.	
richard_t_20120730_107.JPG

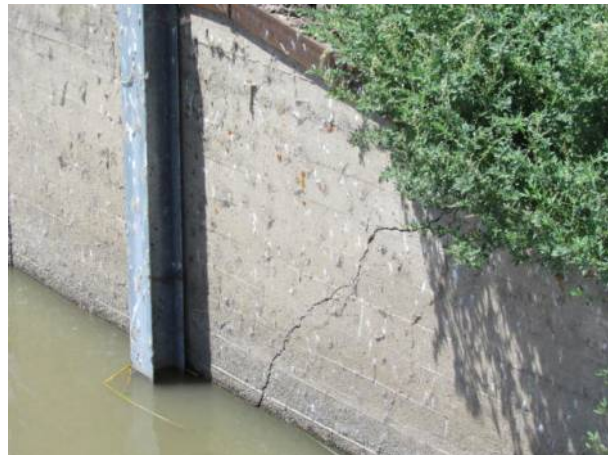
Levee Mile Report Line	15
Start Levee Mile	0.00
End Levee Mile	0.00
Location	
Category	Structures
Item	Concrete Surfaces
Looking at brace on upstream side of structure.	
richard_t_20120730_100.JPG

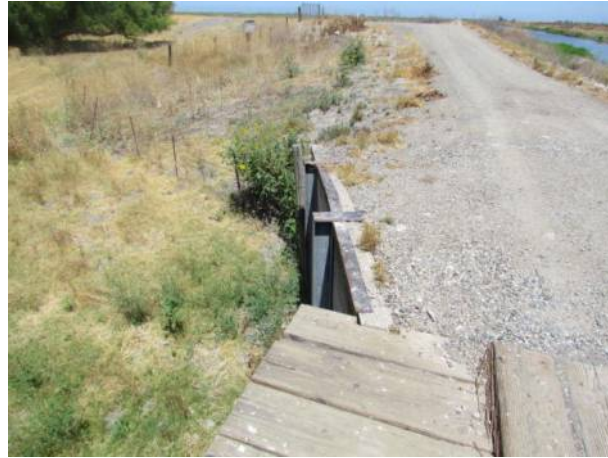
Levee Mile Report Line	15
Start Levee Mile	0.00
End Levee Mile	0.00
Location	
Category	Structures
Item	Concrete Surfaces
Looking at brace on right wing wall on downstream side of structure.	
richard_t_20120730_101.JPG

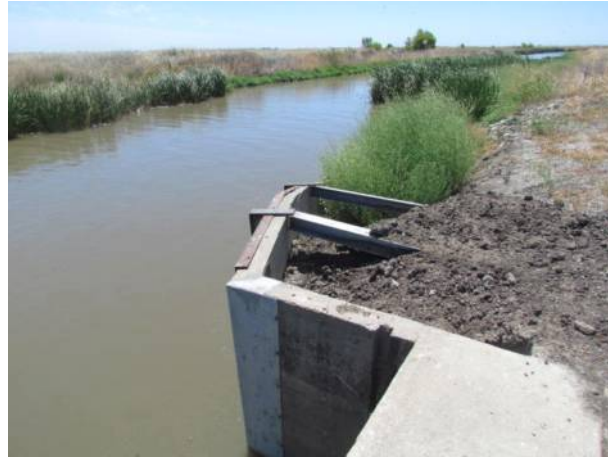
Levee Mile Report Line	22
Start Levee Mile	0.00
End Levee Mile	0.00
Location	
Category	Structures
Item	Monolith Joints
Looking at repaired left wing wall on upstream side of structure. Summer 2012	
richard_t_20120730_099.JPG

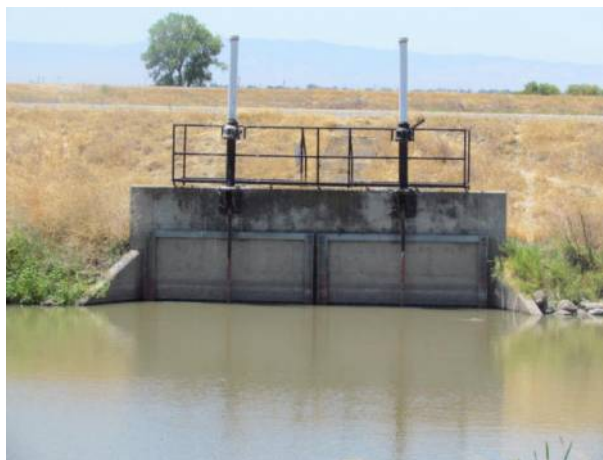
richard_t_20120730_103.JPG

Looking at upstream side of structure.

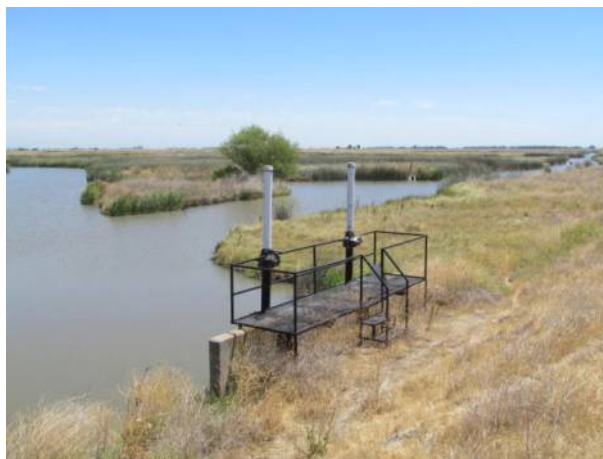
richard_t_20120730_106.JPG

Looking east at manual (screw) gates and platform on upstream side of structure.

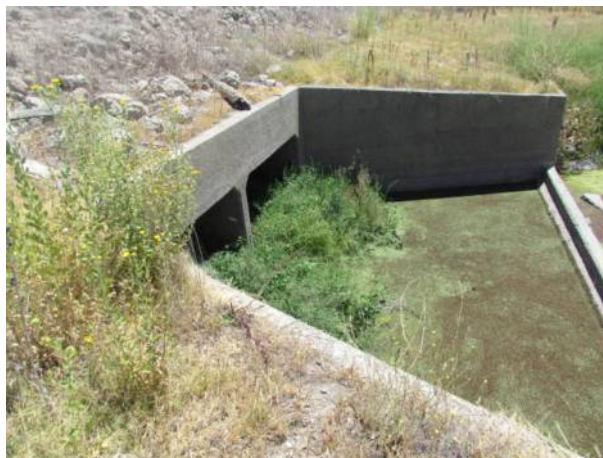
richard_t_20120730_105.JPG

Looking southwest at outlet of structure (Summer 2012)

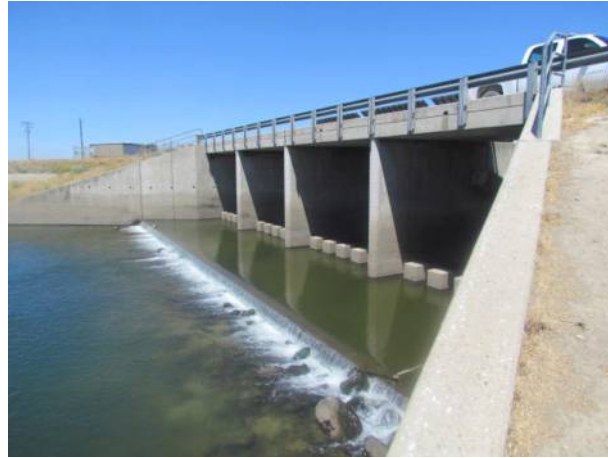
Levee Mile Report Line	1
Start Levee Mile	0.00
End Levee Mile	0.00
Location	
Category	Structures
Item	Photo Documentation
Looking west at downstream side of San Joaquin Control Structure.	
richard_t_20120731_161.JPG

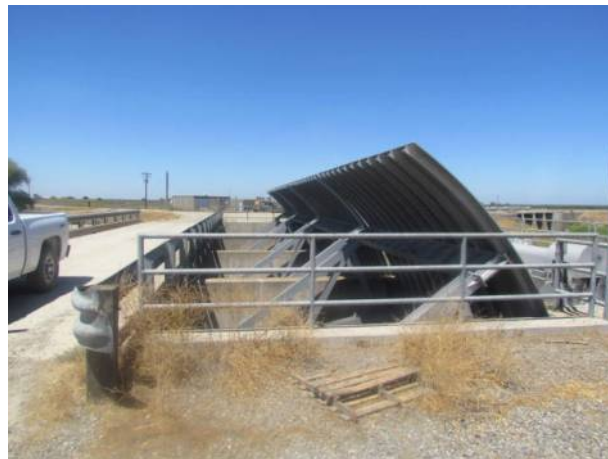
Levee Mile Report Line	1
Start Levee Mile	0.00
End Levee Mile	0.00
Location	
Category	Structures
Item	Photo Documentation
Looking west overview of gates on San Joaquin Control Structure.	
richard_t_20120731_162.JPG

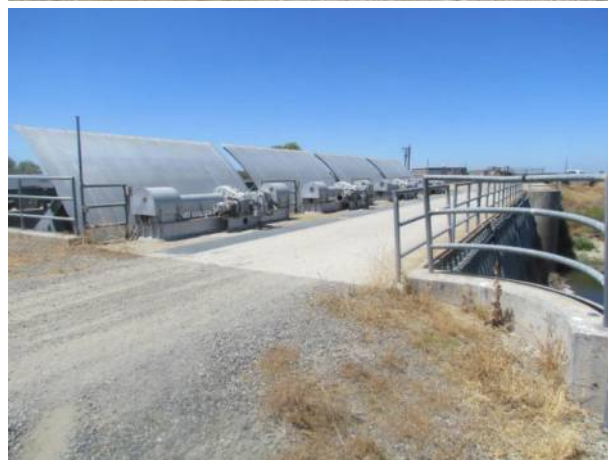
Levee Mile Report Line	1
Start Levee Mile	0.00
End Levee Mile	0.00
Location	
Category	Structures
Item	Photo Documentation
Looking northwest at overview of gates and motors on San Joaquin Control Structure.	
richard_t_20120731_163.JPG

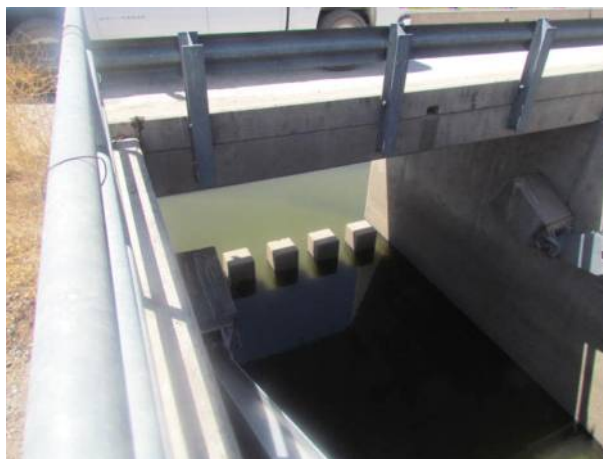
richard_t_20120731_165.JPG

Looking north at typical view of gate bays on San Joaquin Control Structure.

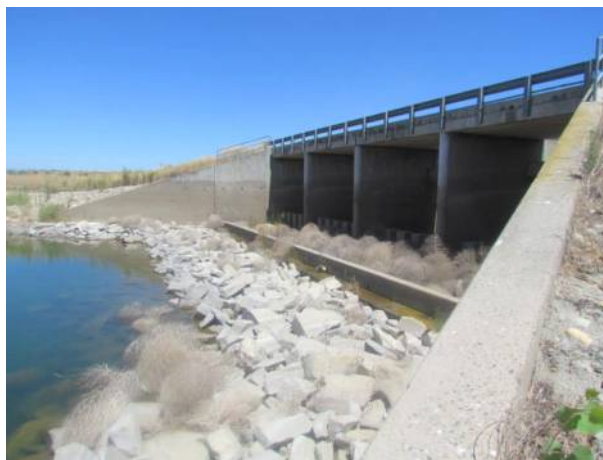
richard_t_20120731_169.JPG

Looking southeast at revetment on downstream side of Chowchilla Control Structure.

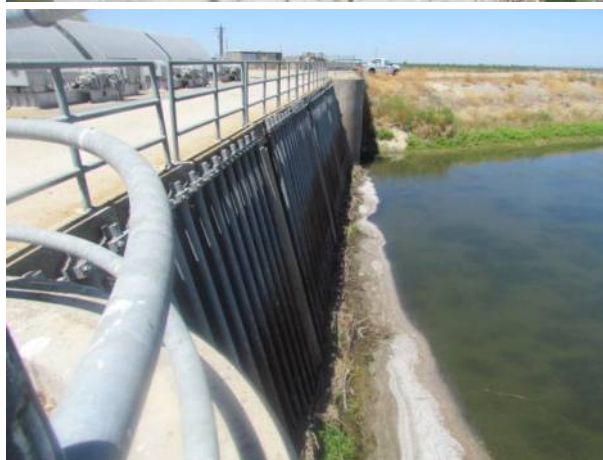
richard_t_20120731_167.JPG

Looking north at trash racks on San Joaquin Control Structure.

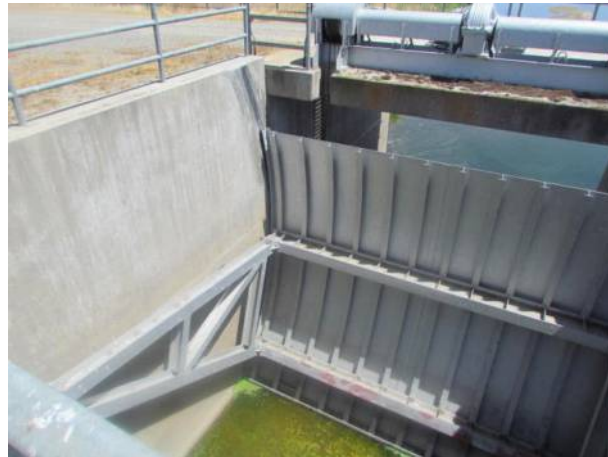
richard_t_20120731_168.JPG

Looking south at typical view of gates on Chowchilla Control Structure.

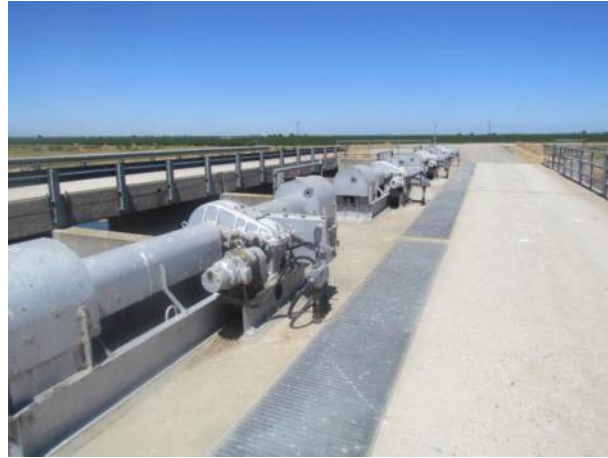
Levee Mile Report Line	13
Start Levee Mile	0.00
End Levee Mile	0.00
Location	
Category	Structures
Item	Electric Gate Operators
Looking east at gate motors on Chowchilla Control Structure.	
richard_t_20120731_166.JPG

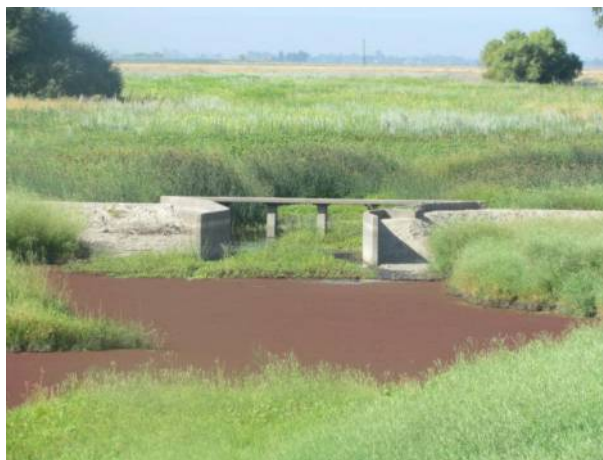
richard_t_20120731_125.JPG

Looking south at overview of San Joaquin Structure.

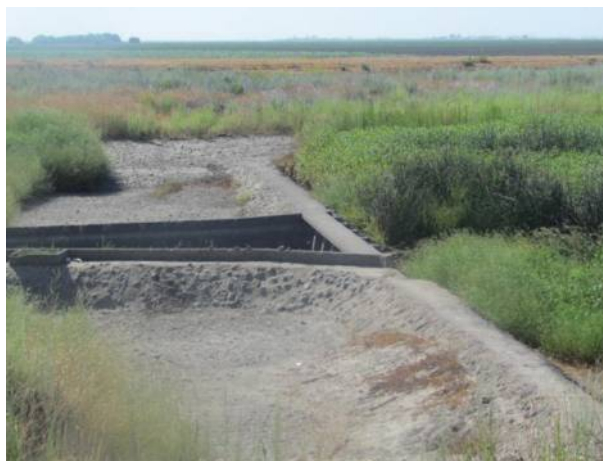
richard_t_20120731_126.JPG

Looking east at overview of San Joaquin structure.

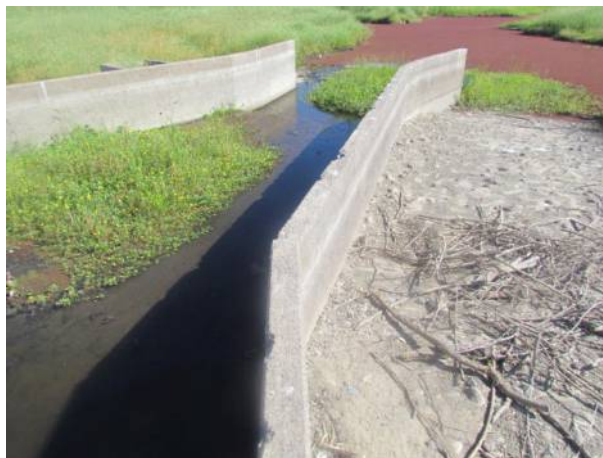
richard_t_20120731_129.JPG

Looking north at right wing wall on San Joaquin structure.

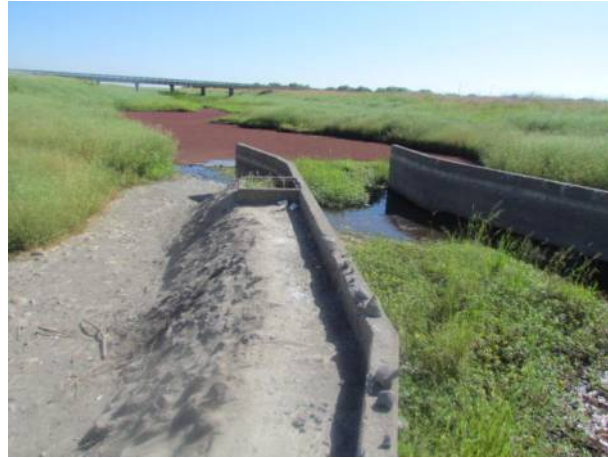
Levee Mile Report Line	1
Start Levee Mile	
End Levee Mile	
Location	
Category	Structures
Item	Photo Documentation
Looking north at left wing wall on San Joaquin structure.	
richard_t_20120731_130.JPG

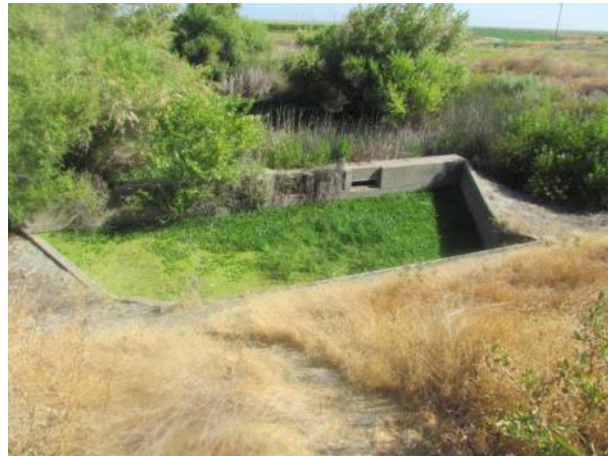
Levee Mile Report Line	7
Start Levee Mile	0.00
End Levee Mile	0.00
Location	
Category	Structures
Item	Culverts: Inlets / Outlets
Looking west at inlet of Sand Slough structure.	
richard_t_20120731_133.JPG

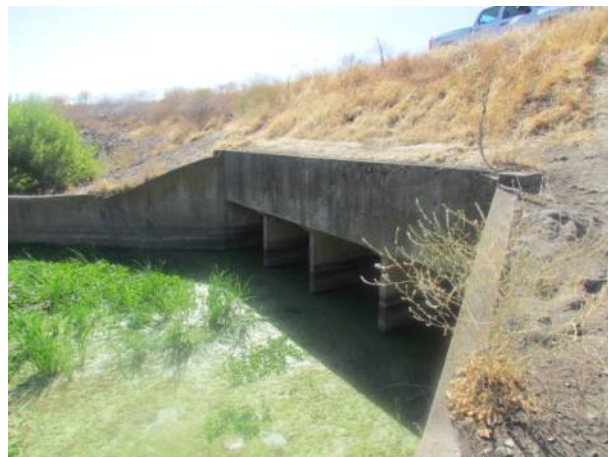
Levee Mile Report Line	7
Start Levee Mile	0.00
End Levee Mile	0.00
Location	
Category	Structures
Item	Culverts: Inlets / Outlets
Looking north at inlet of Sand Slough structure.	
richard_t_20120731_134.JPG

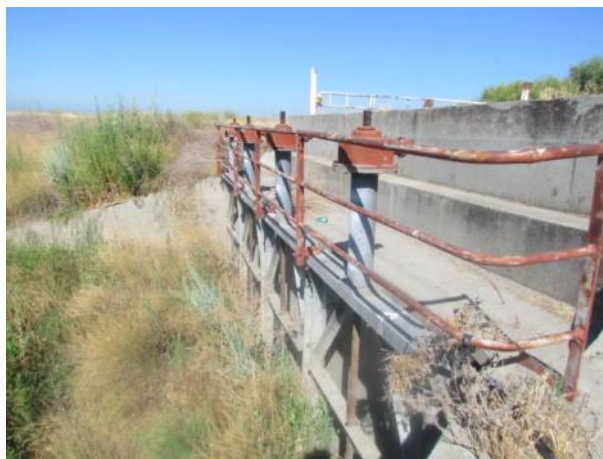
Levee Mile Report Line	12
Start Levee Mile	0.00
End Levee Mile	0.00
Location	
Category	Structures
Item	Sluice/Slide Gates
Looking south at gates on downstream side of Sand Slough structure.,	
richard_t_20120731_131.JPG

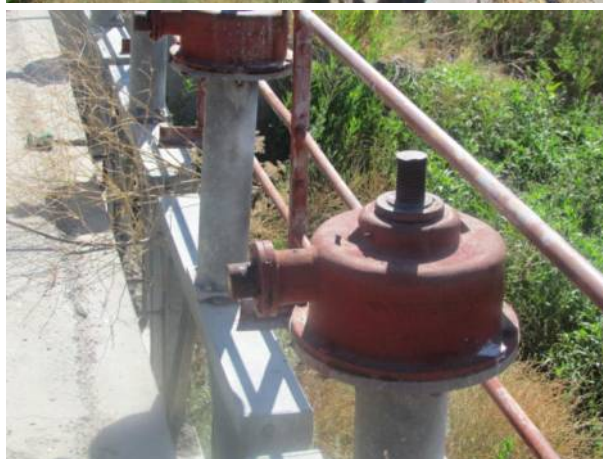
Levee Mile Report Line	12
Start Levee Mile	0.00
End Levee Mile	0.00
Location	
Category	Structures
Item	Sluice/Slide Gates
Looking north at stems cap-off on gates for security.	
richard_t_20120731_132.JPG

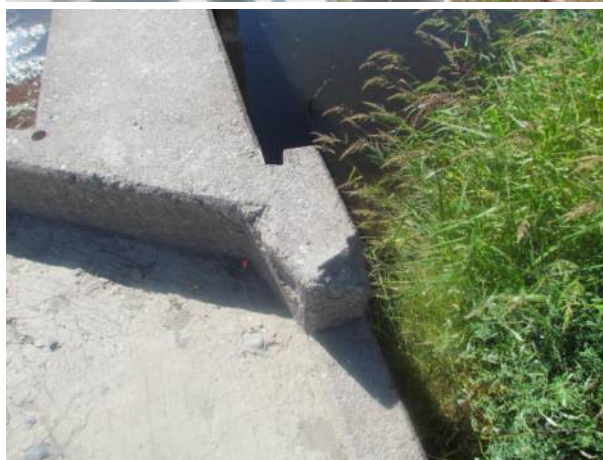
LMR No.	Levee Mile		Category	Item	Location *	Rating **	Action/Comment	GPS Latitude/Longitude		Issue No.
	Start	End						Start	End	Photo
15	0.00	0.00	Structures	Concrete Surfaces		M	Inspector Comments: Cracking on outlet side on left and right corner. Minor cracking on Sand Slough structure.	37.112337 ° -120.589543 °	37.112337 ° -120.589543 °	15 Y
16	0.00	0.00	Structures	Concrete Tilting / Settlement		A	Inspector Comments: No visible movement along this structure.	37.112337 ° -120.589543 °	37.112337 ° -120.589543 °	16
17	0.00	0.00	Structures	Concrete Foundations		A	Inspector Comments: No visible undermining present or near this structure.	37.112337 ° -120.589543 °	37.112337 ° -120.589543 °	17
18	0.00	0.00	Structures	Security Fencing		N	Inspector Comments: Item does not exist on this structure	37.112337 ° -120.589543 °	37.112337 ° -120.589543 °	18
19	0.00	0.00	Structures	Closure Structures		N	Inspector Comments: Item does not exist on this structure	37.112337 ° -120.589543 °	37.112337 ° -120.589543 °	19

Levee Mile Report Line	15
Start Levee Mile	0.00
End Levee Mile	0.00
Location	
Category	Structures
Item	Concrete Surfaces
Looking east at minor chipping on left wall of San Joaquin structure.	
richard_t_20120731_127.JPG

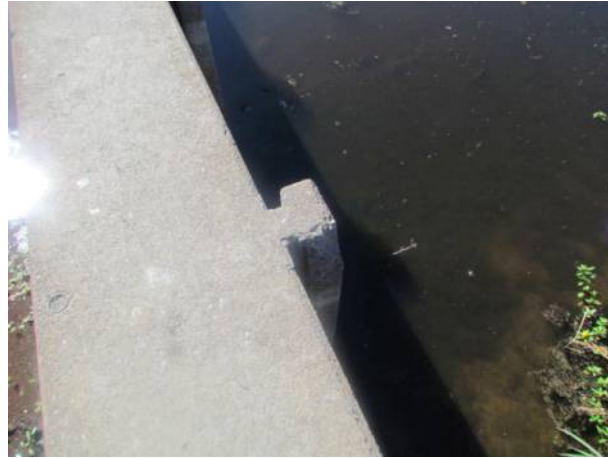
richard_t_20120731_128.JPG

Looking southeast at minor chipping on upstream side of San Joaquin structure.
